A TALE *of* TWO DOTs:

Concrete Bridges and Different Approaches to Metalizing for Corrosion Protection

By **Lori R. Huffman, JPCL**

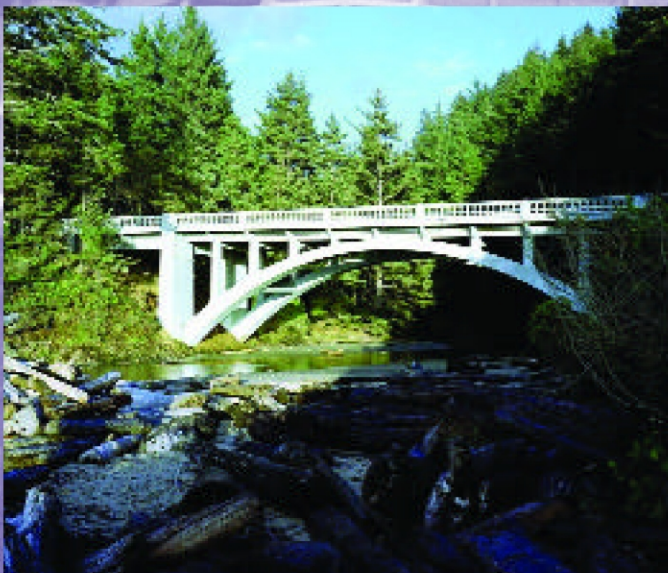
*Cummins Creek Bridge in Oregon, a completed metalizing-cathodic protection project.
Courtesy of the Oregon DOT*

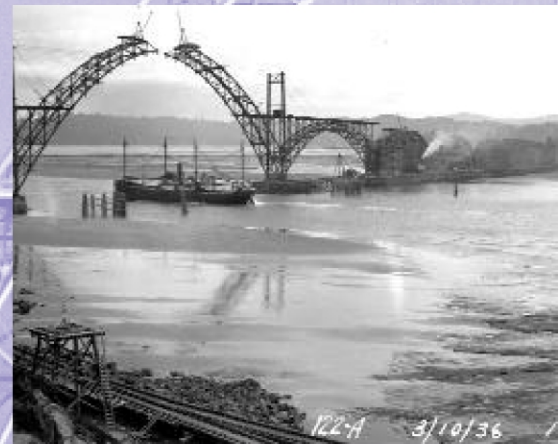
*Yaquina Bay Bridge in Oregon, above and background, 1936.
The bridge was metalized in 1992.
Courtesy of the Oregon DOT*

zinc must be removed and reapplied at this point. According to Cryer, thermal-sprayed zinc on the Yaquina Bay Bridge has begun to expend itself in localized areas. The metalizing project was completed in 1992 on this bridge, and zinc on only one of the towers has been affected. The DOT is investigating the reason for the localized exhaustion of the zinc coating. The first bridge the DOT metalized is still performing well after 15 years in service, Cryer says.

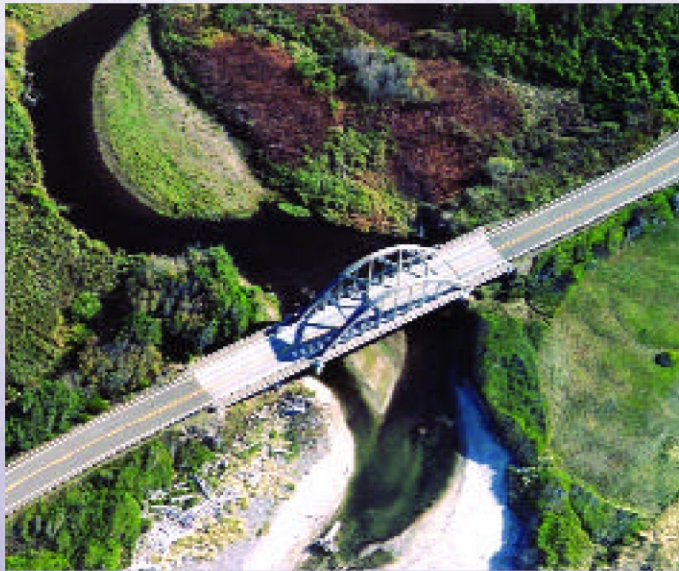
Big Creek Bridge in Oregon, another completed metalizing-cathodic protection project. Courtesy of the Oregon DOT

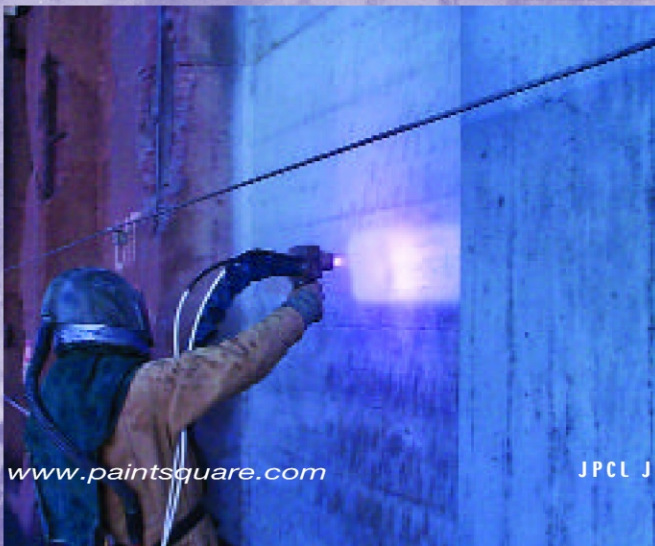
*Metalizing concrete surface
Courtesy of Corrosion Restoration Technologies*

Application of thermal spray zinc is made in several passes to build the metalizing to a thickness of 18 to 20 mils, says Wixson. Multiple application pass-

Measuring the applied thickness of the metalizing on concrete can be difficult, says Wixson. Several strategies for measuring metalizing thickness include the use of ultrasonic thickness testers, steel

reference coupons situated every 100 sq ft in the work site, or the tracking of material consumption during thermal spray operations. According to Wixson, typical consumption is one lb of zinc per sq ft for a 20-mil thickness.

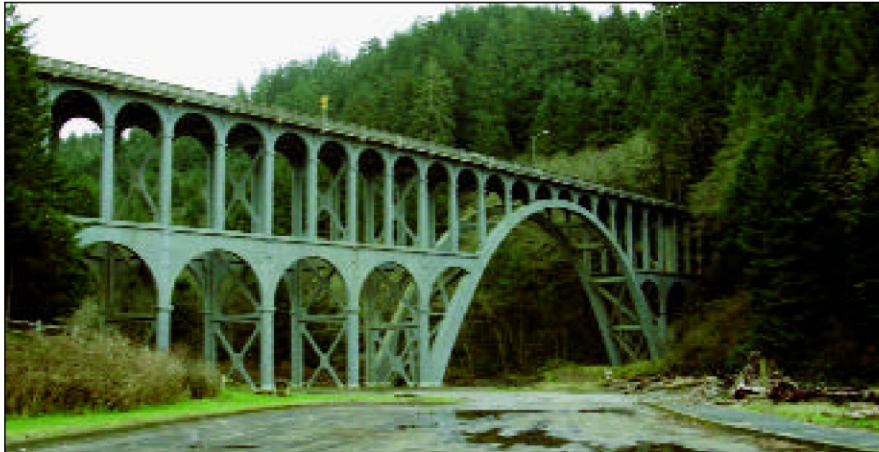
*Cape Creek Bridge, the first of Oregon's historic bridges to be metalized (1991)
Courtesy of the Oregon DOT*

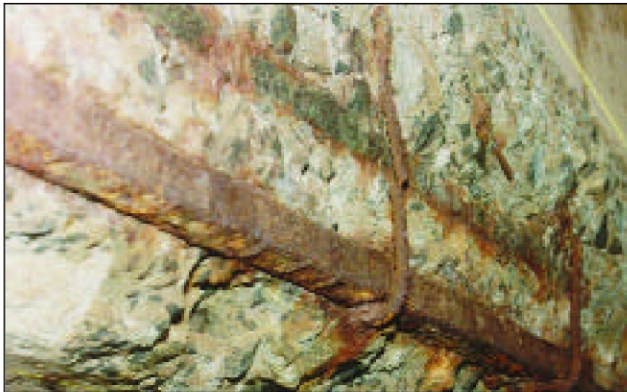
*Typical coastal bridge damage
Courtesy of the Oregon DOT*

is the concrete itself. Once a sufficient amount of chloride reaches the steel rebar, conditions are favorable for the steel to corrode. And, as corrosion products build on the rebar, they push the concrete outward, leading to cracks and eventual spalling.

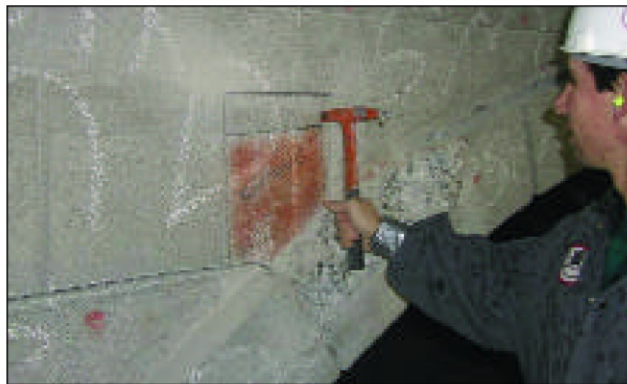
*Sounding for delaminated concrete
Courtesy of Great Western Corporation*

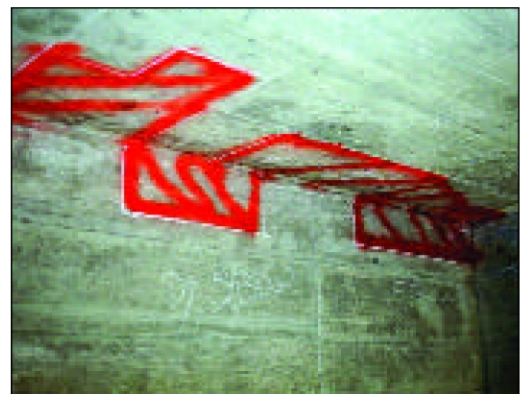
*Delaminated concrete is marked.
Courtesy of Great Western Corporation*

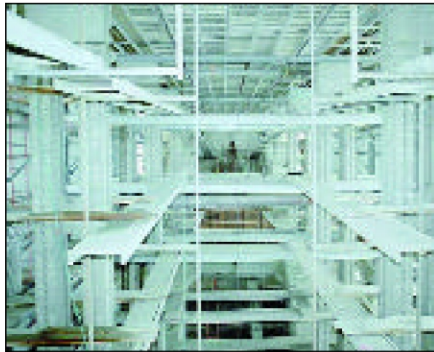
*Interior scaffolding for metalizing
Courtesy of Great Western Corporation*

alizing projects are enclosed to prevent damage to sensitive local environments, such as estuaries, says Cryer.
